Manhole Inspection Summary

Manhole # S11EE2033MH

Insp Date: 11/1/06 11:25 AM

Location Address: **2217 CROSS COUNTRY BLVD**

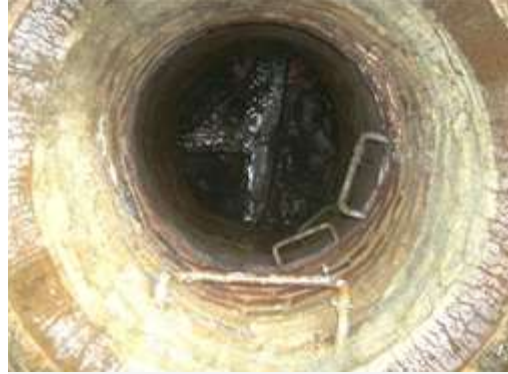
Top View

Adjustment and Barrel infiltration.
Corroded steps. Evidence of surcharge-
Bench debris.

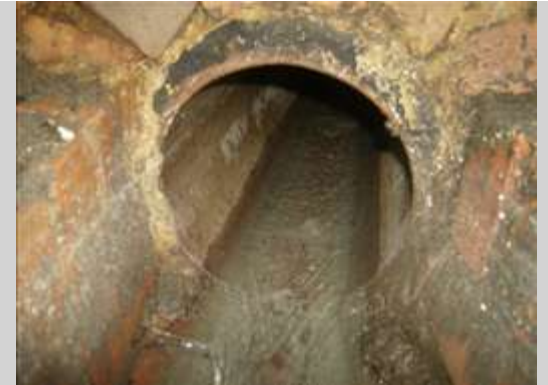
8 in. Circular Gravity Sewer Pipe Out @ 12 O'Clock

Infiltration: **Evidence** Pipe Seal Cond: **Unknown**

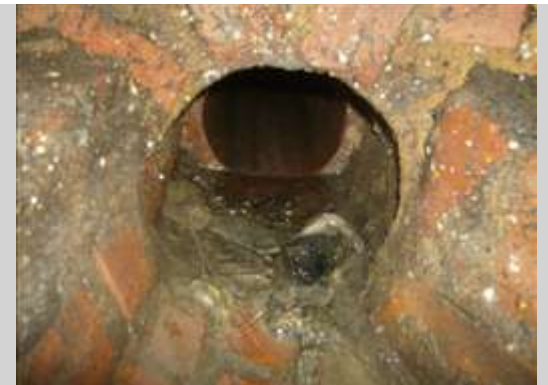
10 in. Circular Gravity Sewer Pipe In @ 6 O'Clock

Deposits: ☐ None ☒ Mud ☐ Sludge ☒ Debris ☐ Grease

Silt Depth: **1** (in.) Deposits Extent: **Light**

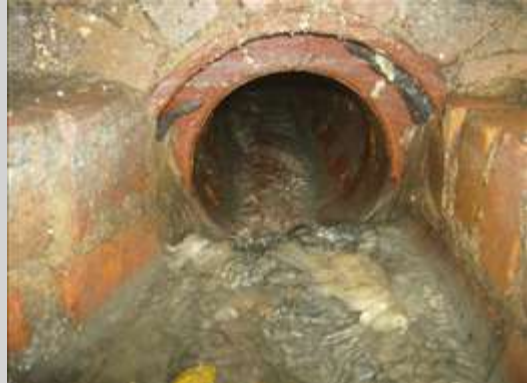
8 in. Circular Gravity Sewer

Deposits: ☐ None ☐ Mud ☐ Sludge ☒ **Debris** ☒ **Grease**

Silt Depth: **0.5** (in.)

Infiltration: **Evidence**
